# **Solar Hills Reserve Study for the Irrigation System 2019**

Feb.11, 2019

# SOLAR HILLS RANCH SUBDIVISION

## RESERVE STUDY

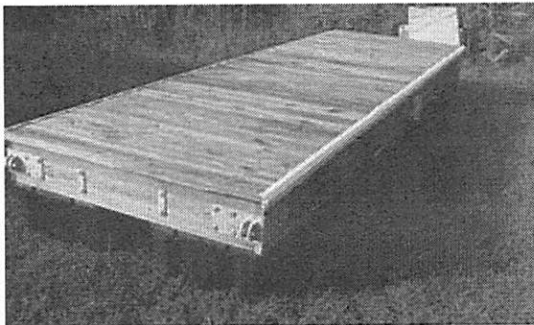
The floating dock system has plastic flotation containers that can support a deck frame. Each unit is 4 feet by 10 feet. Our dock would require 10 individual sections.

A floating dock that is attached to the pylons might be a better solution and would be easy to repair in the future.

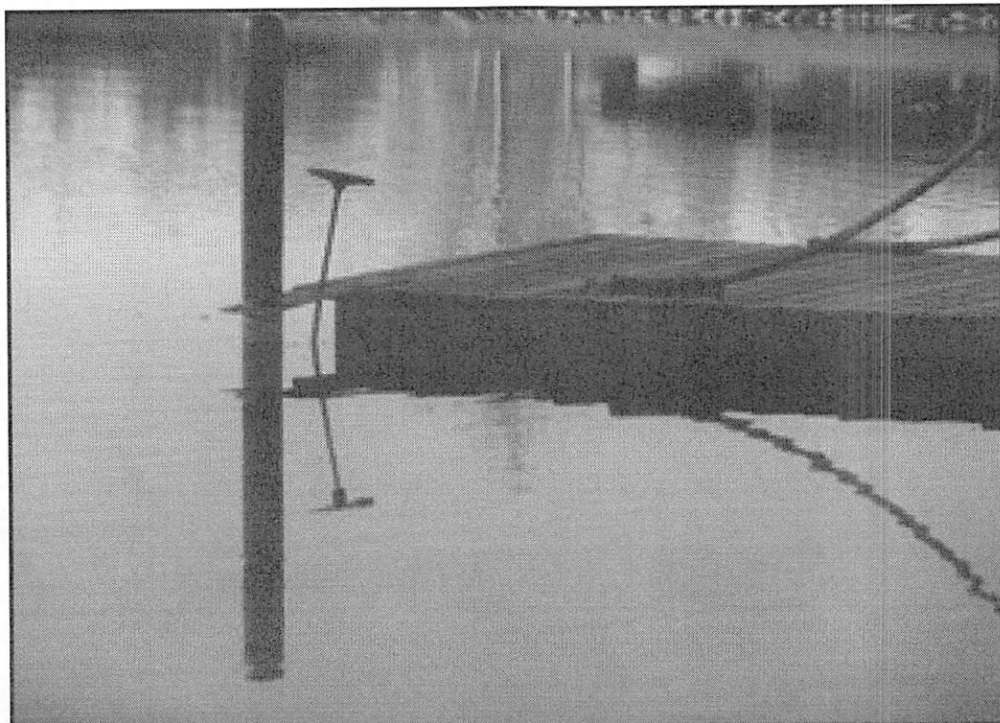
Dock and waterman valve

The irrigation system requires access to the dock control the 12 inch main line. This dock has been repaired a number of times and at this time is in need of repaired.

The dock has 6 wood pylons that support the main deck structure. The dock is 10' x 40'. The existing substructure support beams have failed. An assessment needs to be done to determine how to best fix the dock.
