# **Solar Hills Reserve Study for the Irrigation System 2019**

Feb.11, 2019

# SOLAR HILLS RANCH SUBDIVISION

## RESERVE STUDY

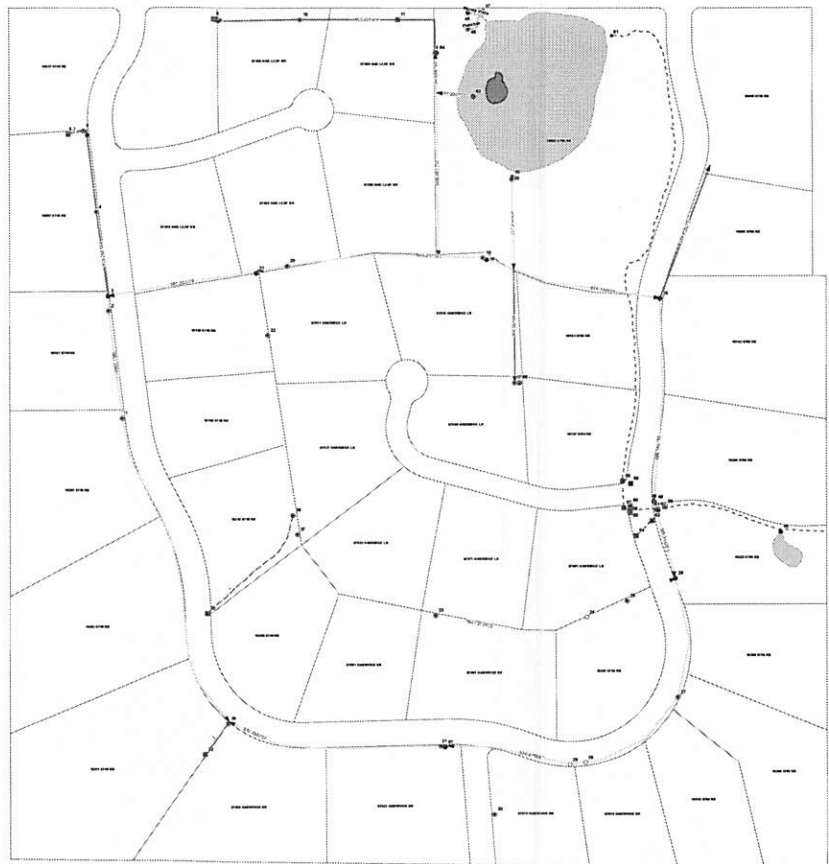
In 2011 physical asset survey and later, we GPS'd all of the valves, lines, drains and air-vacs. We created a map of our system that included a list of all the parts and the actual length and diameter of all of the pipe. The image below is a snapshot of a document that is in our Solar Hills Irrigation folder.
